**Re: Weitsman Shredding, LLC d/b/a Upstate Shredding, LLC  
Compliance Evaluation Inspection – August 4, 2015  
SPDES Tracking No. NYR00D022**

**COMPLIANCE EVALUATION INSPECTION REPORT**

<b>Compliance Evaluation Inspection:</b> Weitsman Shredding, LLC d/b/a Upstate Shredding, LLC
<b>Inspection Date:</b> August 4, 2015 <b>Inspection Time:</b> 1:00 PM – 6:00 PM
<b>EPA Inspector:</b> Katherine Mann, Physical Scientist, USEPA Region 2, DECA, Water Compliance Branch (212) 637-4226
<b>On-Site Representative:</b> Adam Weitsman, Owner, Office: (607) 687-7777, Cell: (607) 760-8204
<b>Site Information:</b> 1 Recycle Drive, Owego, NY 13827; SPDES No. NYR00D022
<b>Owner/Operator/Permittee:</b> Weitsman Shredding, LLC  Adam Weitsman, Owner, P.O. Box 420, Owego, NY 13827
<b>SIC Code:</b> 5093 (Scrap and Waste Materials)

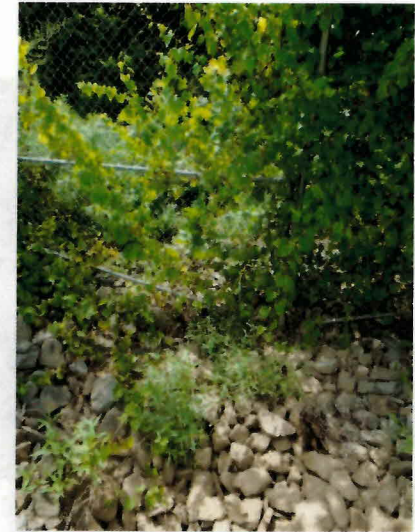
P8040059	Weir at Outfall 001 (with sediment build-up on pond side of the weir)
P8040060	Discoloration at low flow discharge point from the weir
P8040061	Close-up of discoloration at low flow discharge point from the weir
P8040062	Rip rap downstream of Outfall 001 (Owego Creek is located beyond the fence line)
P8040063	Sediment build-up on pond side of the weir
P8040064	Close-up of sediment with sheen on the pond side of the weir (at Outfall 001)
P8040065	Spill observed on the ground just north of the stormwater pond
P8040129	55-gallon drums containing various liquids stored outdoors on the northwest side of the Site. Some of the drums were situated in a secondary containment structure, and others were stored without secondary containment.

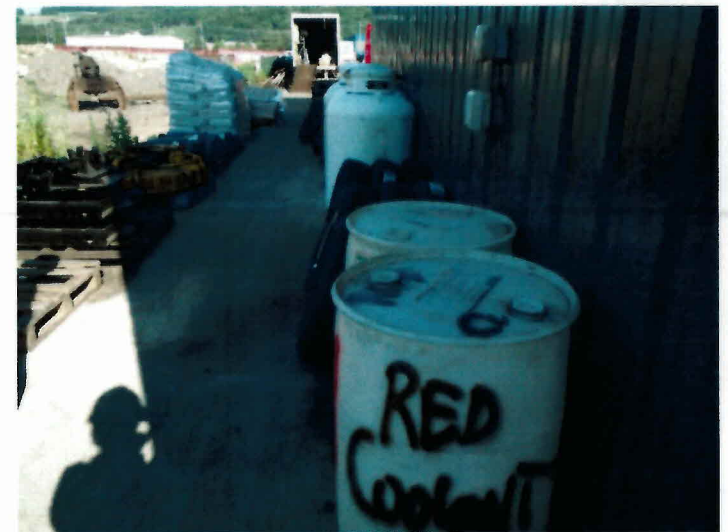
P8040130	Tires stored outdoors on the west side of the new maintenance garage (northwest side of the Site)
P8040131	55-gallon drums of coolant, tires, and other materials stored on wooden pallets on the north side of the new maintenance garage
P8040132	Culvert in the ditch that drains west to Outfall 002. Some sediment accumulation was observed in the ditch at the time of the CEI.
P8040133	Miscellaneous paint cans and metal parts stored outdoors just north of the drainage ditch near the new maintenance garage
P8040134	Empty paint cans in trash receptacle stored outdoors just north of the drainage ditch near the new maintenance garage
P8040135	Downstream end of culvert pipe identified in P8040132, with vegetated drainage path to Outfall 002
P8040136	Leaking heavy equipment stored outdoors, without drip pan, on the west side of the Site
P8040137	Leaking heavy equipment stored outdoors, without drip pan, on the west side of the Site; additional staining to the pavement in the foreground
